Historic Structures Report

Levi Lowe House

Randolph, New Hampshire

Levi Lowe House
1270 Presidential Highway (Route 2)

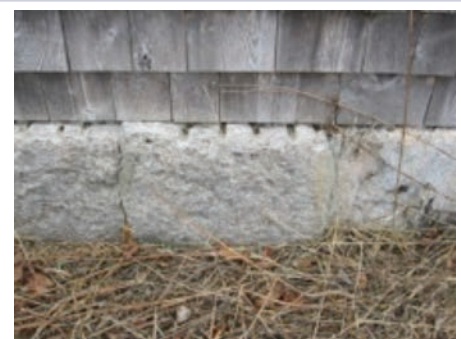
As mentioned in the history section above, the Lowe House is a one-and-a-half story, side-gabled cape. It may have been built originally as a five-bay style cape, but it now reflects late 19th and early 20th century changes. It is clad with wood shingles and plain corner boards, casings, and cornice returns. Early twentieth century photographs show that it had been clad with wood clapboards. The house sits on a granite block and fieldstone foundation. The stone splitting marks visible on the granite blocks are from a plug drill, which were used post 1830.¹⁴ The central,

Stone splitting marks visible from plug drill – post 1830.

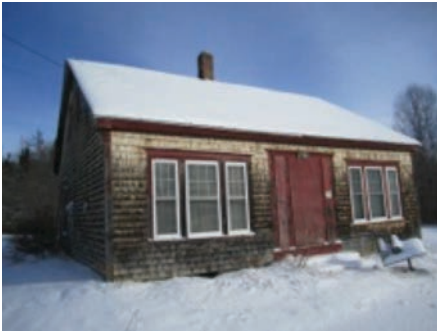
South façade.

The main entrance is located on this south elevation. It is centered on the façade flanked by sidelights, though both the sidelights and the door have been boarded up for several years now. There is symmetry in the composition of the fenestration, though the

tripartite window arrangement is an early 20th century change and the 6/1 window late 20th century replacements. The front steps are cut granite blocks.

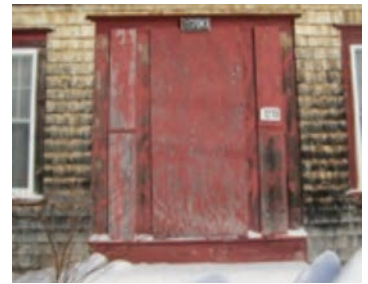
Front door and sidelights.

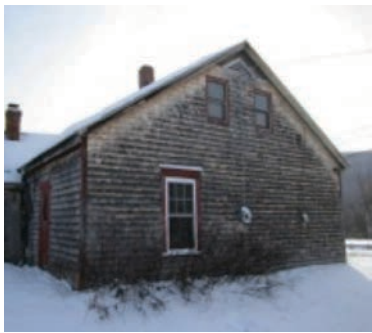
West elevation of the main house.

Only one bay, 6/1 window sash on the first floor. Two bays in the gable peak with 1/1 window sashes. Again, these sashes are late 20th century replacements.

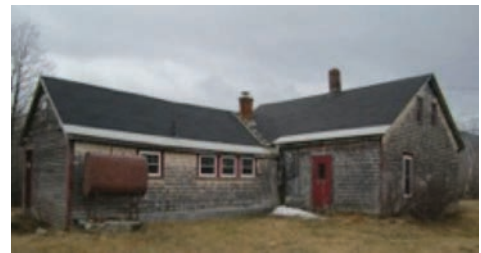
the house, the rear, there are two bays containing doors. The door closest to the west elevation is the only entrance into the two rooms on the west side of the first floor. These rooms had been turned into a two-room apartment near the turn of the 20th century. To the left of this door is another door that was covered over with shingles, most of which have fallen off. This doorway led straight into the interior stairs.

West elevation of the ell. North elevation of house.

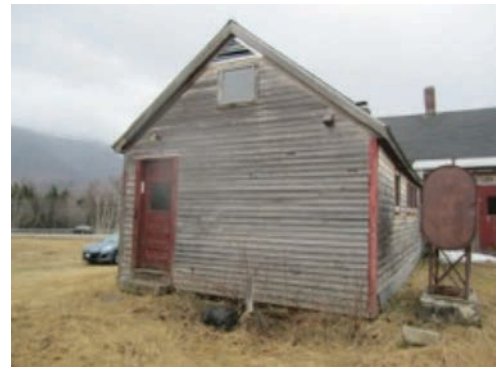
On the eastern side of the north elevation, a 1-½ story ell was added that dates from latter part of the 19th century. It is clad with wood clapboards and plain corner boards on the north elevation, wood shingles on the east and west elevations, and is set on granite block foundation. Asphalt shingles cover the roof and a single brick stove chimney sits at the juncture of the house and ell. There are two bays, a turn of the 20th century door and a single casement window in the gable peak bay on the north elevation and a mix of 19th and 20th century sashes on the east and west elevations.¹⁵

Kitchen ell north elevation.

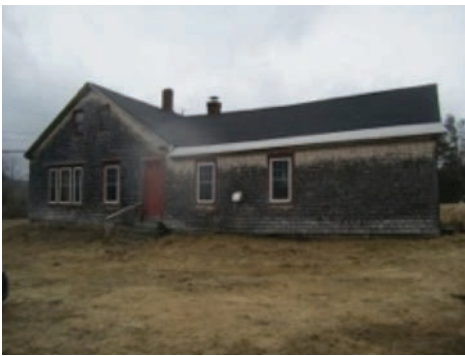
East elevation.

A tripartite window, similar to the front façade and a single 6/1 window sash are on the first floor while two 1/1 window sashes are in the gable peak. They are all late 20th century replacement sashes. A third bay at the end of the main house, before the juncture of the kitchen ell, is a door. It is a 20th century six-panel, metal clad replacement door.

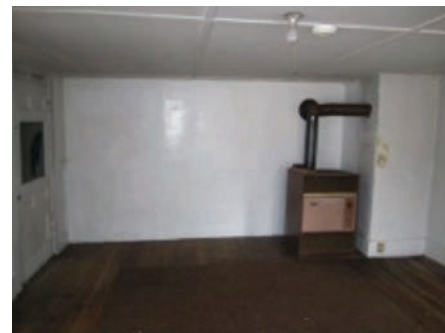
Over the years alterations were made to the interior. Originally the house floor plan was likely of rooms that flanked the central stove chimney. The front parlors were divided by a solid wall, possibly at the latter part of the 19th century. This alteration distinctly changed the character of a typical cape floor plan, though it is a reversible change.

The solid wall divided the front rooms on the first floor, creating a separate apartment.

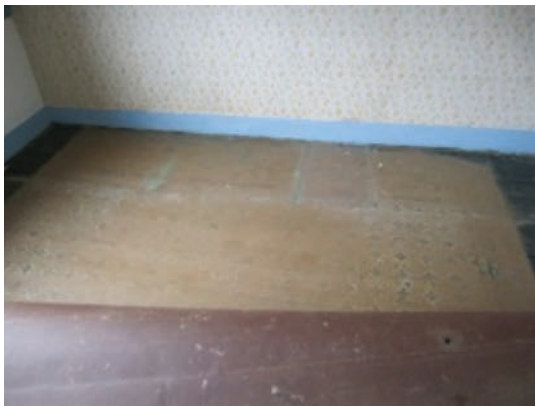
Originally the walls would have been finished with animal hair plaster and lath, with plain, painted wood trim. Evidence of wallpaper was found in different rooms of the house. More research would be required in order to determine the periods of the paper. The upstairs rooms revealed original wide-pine board floors painted, and two with floor cloth coverings. There are three older doors that are the Greek Revival style four panel doors with mortise-and-tenon joints hung with cast iron double-barrel or fixed pin hinges, also known as cast-iron loose joint butt or cast-iron butt, fixed pin. One is in the northwest room of the apartment, another at the stairs going up to the second floor, and the third is the bathroom door. Upstairs the catches for door latches are still attached to the doorjamb. Though the doors are gone, these are evidence that they had been cast iron latches, likely a plain Norfolk latch or a Suffolk latch given the simpler style of finishes throughout the house. Lastly, as previously mentioned, wood stoves heated the house.

Painted floor cloth in east bedroom upstairs.

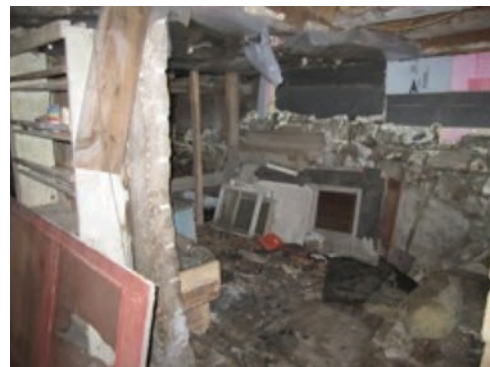
Fieldstone walls capped with granite blocks surround the dirt-floor basement. Various materials have been used on the walls to try and insulate from spray foam insulation – an irreversible alteration –, to rigid insulation, to plaster and lath. Most have been

Basement: a variety of insulation can be seen on the foundation wall and the granite post with its splitting marks.

applied to the granite blocks. Split granite posts as well as some wooden posts give support to the floor joists above. There are wood shelves for storing food, that still hold many glass jars and containers, in the center of the basement, and in the southwest corner below a basement window a stall-like structure, perhaps for storing root vegetables.

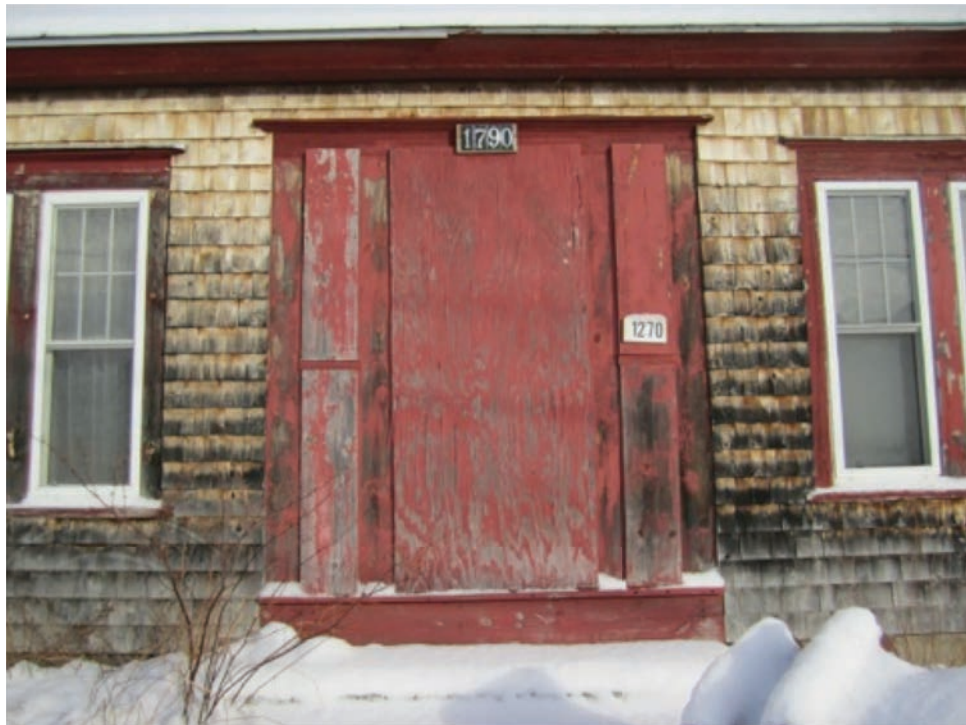
Front door and sidelights boarded up.

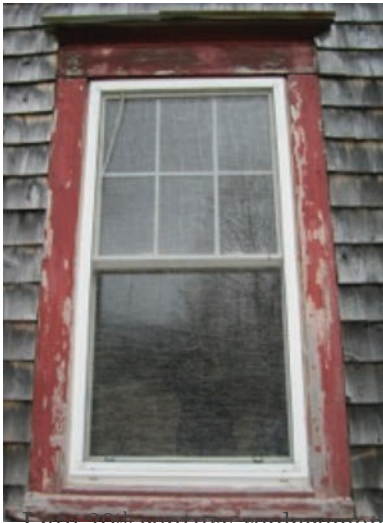
Late 20th century replacement window sashes.

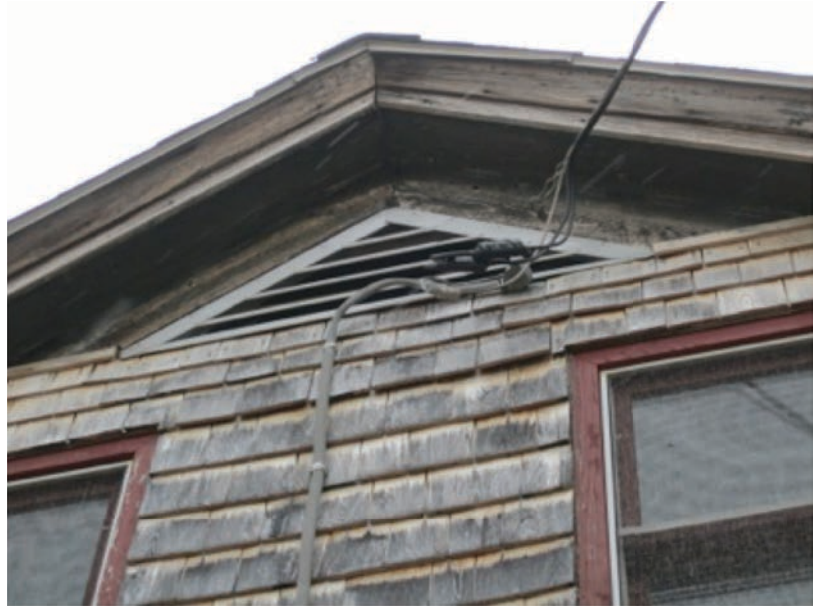
Trim detail covered by wood shingles.

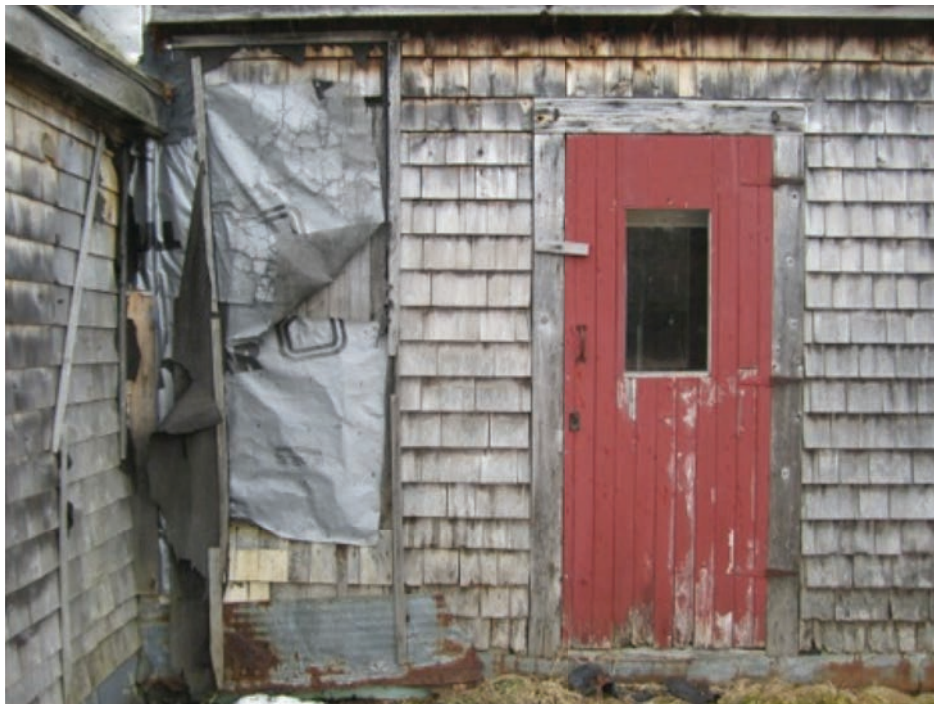
Rear door, north elevation, which is only entrance into the apartment on the west side of the house. There is a door to the left of the red one that was covered over. It opens directly into the stairway leading upstairs.

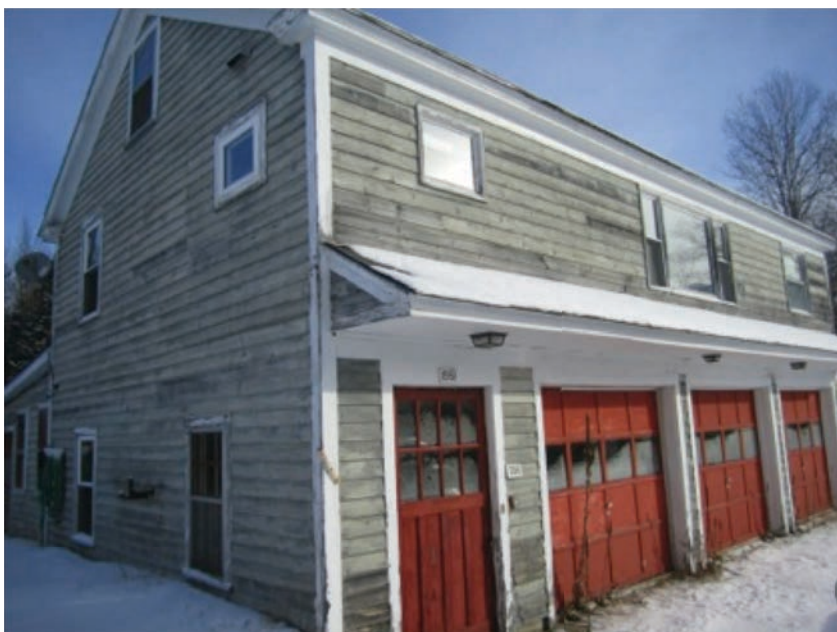
1961 Apartment and three-car garage built by Mildred Farrar's second husband Harvey Webster. South elevation.

century three-car garage and second floor apartment. From a budgetary perspective, the mid-century garage and apartment may be less expensive to maintain the building's integrity. It may have the dual purpose of a workshop and office space or living quarters that would suit the RCFC. The vehicular shed, once cleaned out, may also serve a constructive purpose.

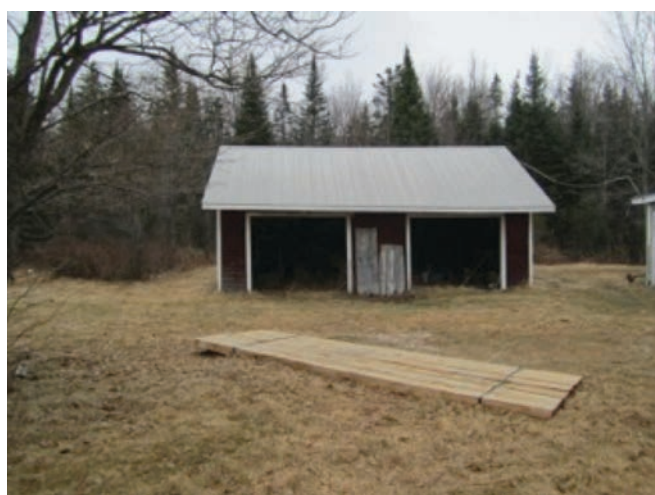
Early 20th century vehicular shed. South elevation.

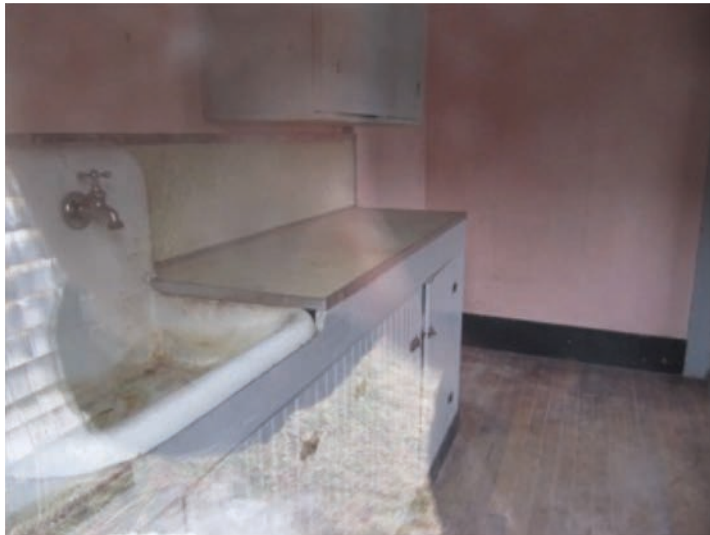
Northwest room, first floor of the house. This is part of the two-room apartment.

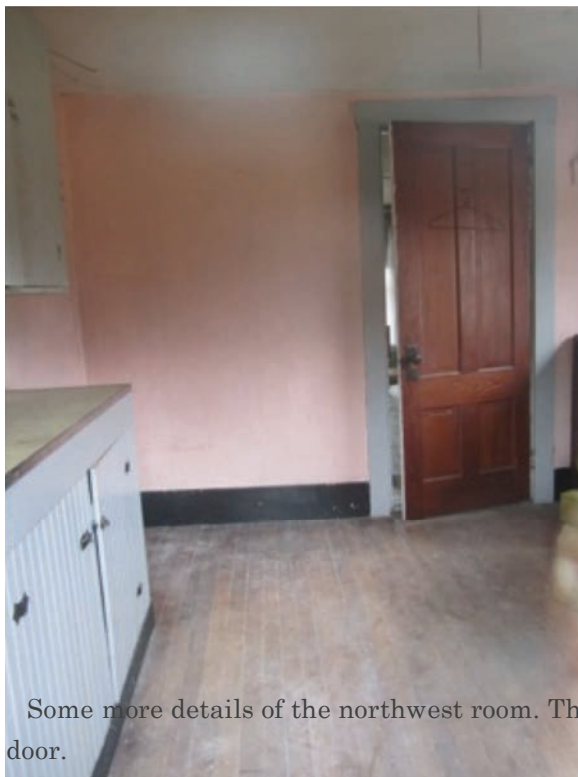
Some more details of the northwest room. The Greek Revival, four panel door.
